# Preventive Design and Analysis of Cavitation Noise on Diesel Engine

## Abstract

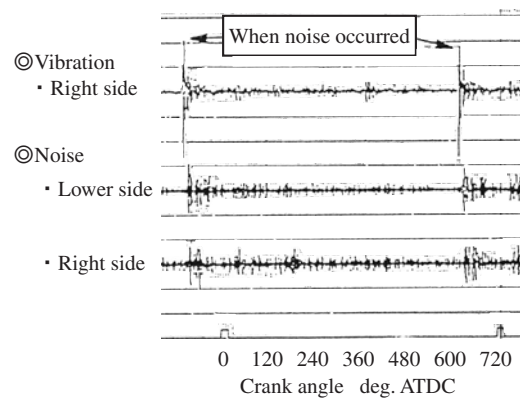
**Fig. 1** Cylinder block vibration and noise.

The operational condition of noise occurrence is shown in **Table 1**. The noise occurred at the 7th main bearing in the cylinder block at the time of the 5th cylinder combustion as shown in **Fig. 1**. The frequency of noise was over 5 kHz, and this noise occurred unperiodically.

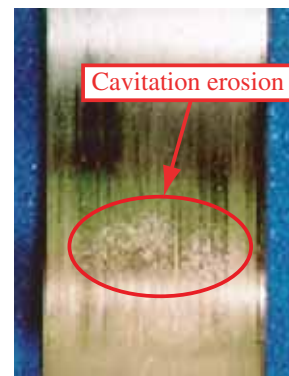
**Fig. 2** Cavitation erosion on bearing surface.

The cause of noise was investigated on an actual engine. No contact between the crankshaft and bearing was observed. On other hand, cavitation erosion was observed on the bearing surface as shown in **Fig. 2**. Therefore, the cavitation seemed to be one factor of the noise occurrence. The mechanism of noise occurrence was assumed by using the following three conditions as shown in

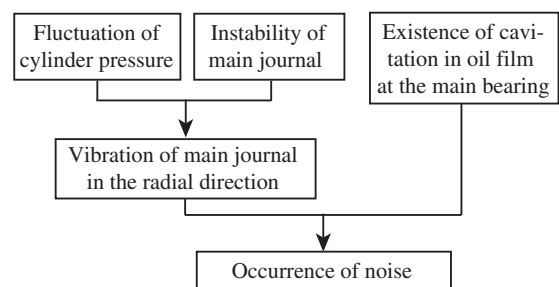
**Fig. 3** Assumption of noise occurrence mechanism.

**Fig. 3**, and the assumption was verified as described in the following sections.

The cavitation in the 7th main bearing under the noise occurrence condition was calculated using the load data and the calculating condition in **Table 2**. A large degree of cavitation existed at the time of noise occurrence as shown in **Fig. 5(a)**. This agrees with the assumption shown in Fig. 3. The cavitation existed in the cap side of the bearing as shown in Fig. 5(b). If the crankshaft vibrated in the radial direction in this situation, it caused the further appearance and collapse of the cavitation in the oil film of the main bearing.

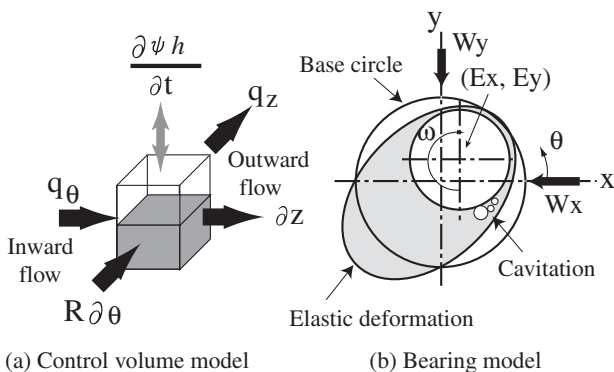
**Fig. 4** Elastohydrodynamic lubrication model.

Elastohydrodynamic lubrication analysis which considered mass conservation of the oil flow in the oil filled and cavitation areas<sup>1, 2)</sup> was conducted for confirmation of cavitation in the oil film. The analysis was defined by using the relation between the inward and outward flows which considered a fill ratio of oil,  $\psi$ , in a control volume as shown in

**Fig. 4(a).** The cavitation in the oil film was calculated by considering the equation of continuity including the fill ratio and the oil film thickness including elastic deformation of the main bearing. The bearing loads  $W_x$ ,  $W_y$  of input data were calculated by the engine vibration analysis.<sup>3)</sup>

When the 7th main journal is unstable and an exciting force exists simultaneously, the main journal vibrates. Stability analysis of the main journal was introduced to investigate the vibration of the crankshaft at the time of noise occurrence. The bearing oil film model shown in Fig. 4(b) was expressed by Reynolds' equation.<sup>4)</sup> The linear stiffness  $[K_b]$  and damping  $[C_b]$  of the oil film were defined as Eqs. (1) and (2) by deformation of Reynolds' equation. Two bearing models were defined to express the translational and rotational displacements of the main journal as shown in **Fig. 6**. When the displacement vector

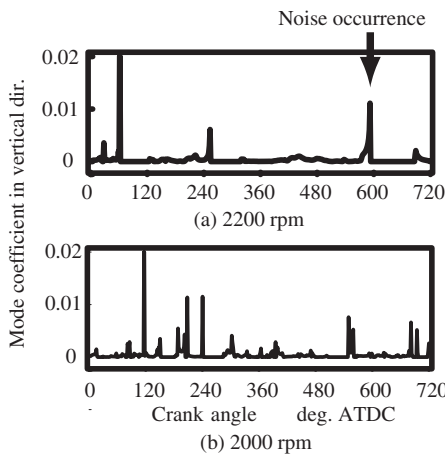
Fig. 7 Mode coefficient of the most unstable mode.

The instability of main journal was defined by the sign of the real part of the complex eigenvalue. The maximum of the real part in the mode vector of the complex eigenvalue was selected at every time step, and the vertical component of the mode vector was shown in Fig. 7. The eigenmode of the journal-bearing system became unstable at the time of noise occurrence. Therefore, when an excitation force such as a fluctuation in the combustion pressure acted on the crankshaft, the crankshaft probably vibrated violently in the vertical direction.

The combustion pressure fluctuated with high-frequency at the time of the noise occurrence as shown in Fig. 8. The high-frequency fluctuation of the combustion pressure changed cycle by cycle, which was considered to be related to unperiodical noise. The noise occurrence condition at 2200 rpm was constructed by combining the three conditions as shown in Figs. 5, 7 and 8.

The conditions under which the noise did not occur were applied to the above mechanism of noise occurrence. For example, the noise did not occur at 2000 rpm as shown in Figs. 5(a) and 7(b). The noise did not occur unless the three parameters were combined simultaneously, thus strengthening the validity of the proposed mechanism as shown in Table 3.

Parameter B : Instability of 7th main journal (Fig. 7)

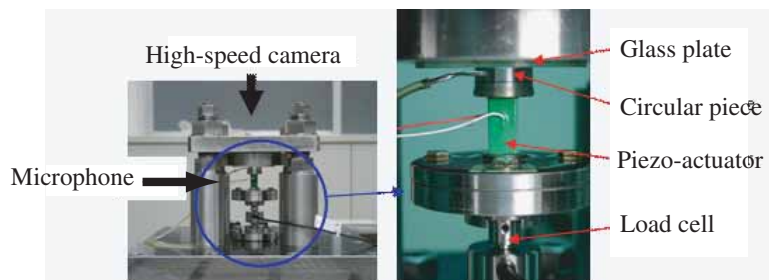
Fig. 9 Test rig for cavitation observation and noise measurement.

The observation of the excited oil film and the measurement of the noise were conducted in a test rig based on the mechanism of noise occurrence in order to investigate the relation between the cavitation and noise as shown in Fig. 9. The test rig was composed of a circular piece and a glass plate with the same clearance as the bearing clearance, and the clearance was filled with engine oil. The diameter of the circular piece was the same as the width of the main bearing of the engine. When the circular piece was excited in the vertical direction by using a piezo-actuator, the oil film was observed through the glass plate using a high-speed camera. At the same time, the noise was measured using a noise meter through a microphone, and the oil film

load was measured using a load cell simultaneously.

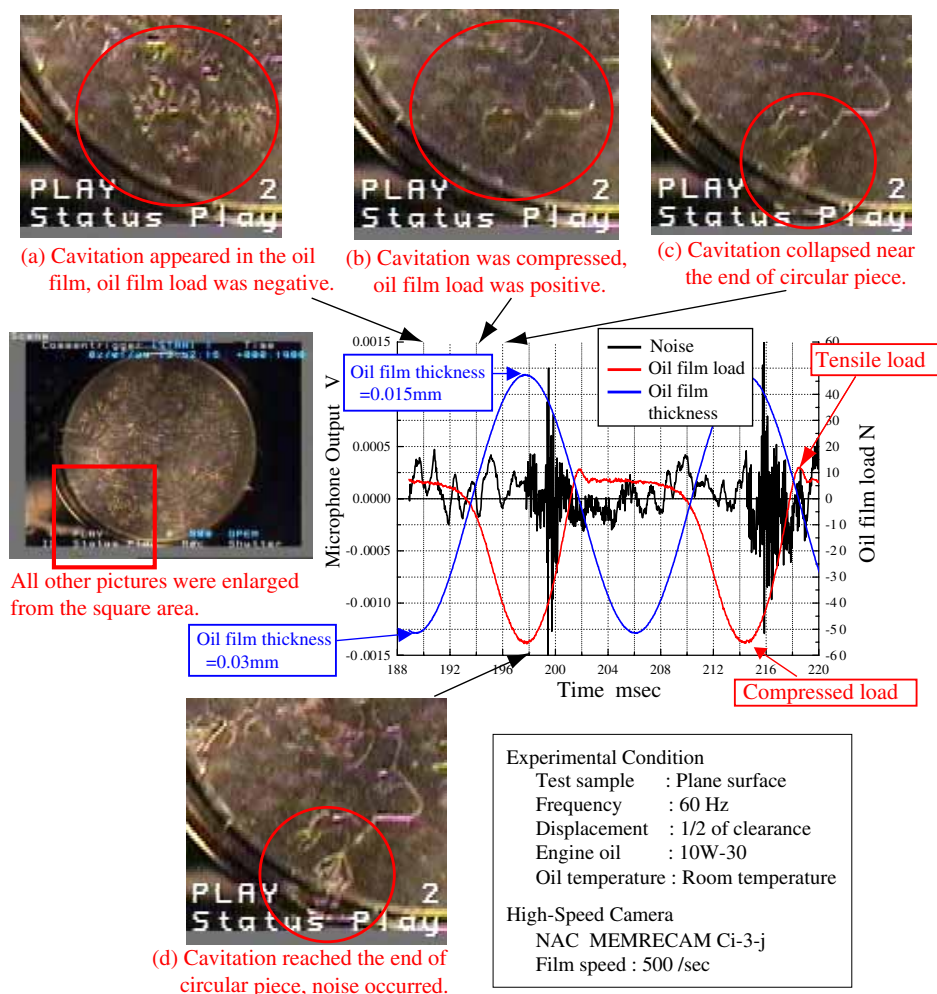
Fig. 10 Relation between cavitation and noise.

The relation between the cavitation and noise was shown in Fig. 10 when the circular piece was excited with half the maximum clearance and the frequency of 60 Hz. When the clearance was maximum, the oil film load was negative and cavitation appeared as shown in Fig. 10(a). Next, as the clearance became small, the cavitation size also became smaller as shown in Fig. 10(b) and the cavitation collapsed by the positive oil film load which was observed to be "lightning shape" as shown in Fig. 10(c). However, the noise did not occur because the collapsed cavitation had not yet reached the outer edge of the circular piece. When the cavitation reached the edge of the circular piece, noise occurred as shown in Fig. 10(d).

(2) Cavitation appeared at the negative oil film load and collapsed at the positive oil film load, which was clarified by the visualization test of the excited oil film based on the above mechanism. Noise occurred when the collapsed cavitation reached the atmosphere.

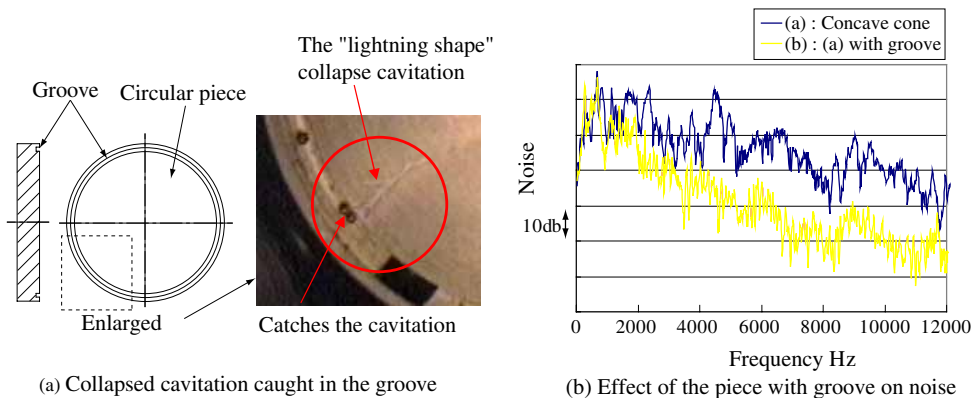
**Fig. 11** Observation of cavitation in the groove.

Secondly, a ring groove was cut at the periphery of the circular piece and filled with engine oil to prevent the collapsed cavitation from reaching the atmosphere. The cavitation stayed in the groove and did not reach the outside atmosphere, as shown in **Fig. 11(a)**. As the result, the noise did not occur. Figure 11(b) shows the noise reduction for frequencies over 4 kHz which was achieved by using the ring groove.

(3) The noise was prevented by cutting ring groove at the periphery of the circular piece and filling with engine oil to prevent the collapsed cavitation from reaching the atmosphere. The cavitation stayed in the groove and the noise did not

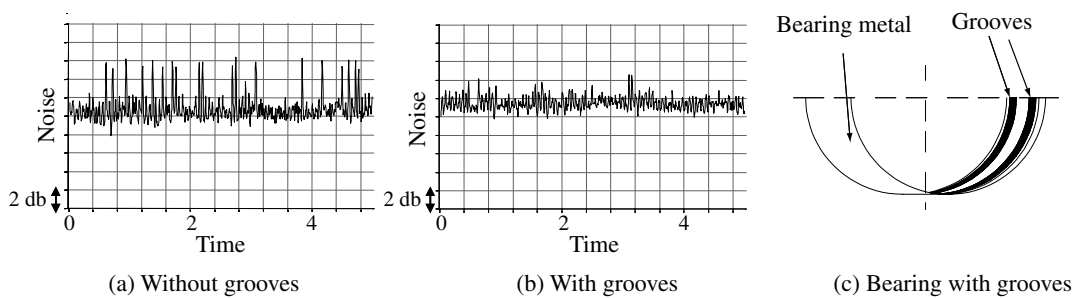
**Fig. 12** Effect of the bearing with grooves on noise.

Finally, the bearing with grooves was made and applied to an actual engine to investigate the effect. The grooves were cut at both ends of the bearing, as shown in **Fig. 12(c)**. The noise which occurred unperiodically at the bearings without the grooves as shown in Fig. 12(a) did not occurred at the bearings

with the grooves as shown in Fig. 12(b), confirming the preventive effect of the grooves.

occur. Bearings with grooves cut at both ends were applied to an actual engine, and tests showed that the noise did not occur, thus confirming the noise-preventive effect of the grooves.
